The Teatro Colón in Buenos Aires. Preservation of acoustic quality during the latest restoration work.

ABSTRACT

Keywords: Teatro Colón in Buenos Aires, acoustic restoration.

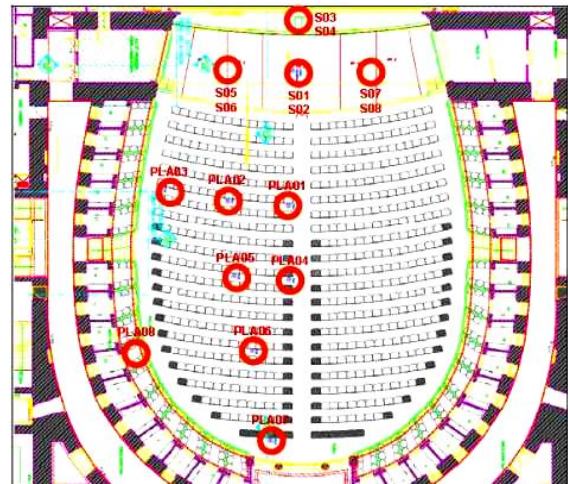
Figure 1 – Positions of the omnidirectional source, on the stage and in the pit, and measurement points in the stalls (After [6])

The measurements in the hall were carried out by the Argentine Institute of Acoustics, Electroacoustics and Related Areas and certified by the Argentine Institute of Standardization and Certification IRAM -ISO representative in Argentina-. A normalized omnidirectional source (dodecahedron), excited with logarithmic sinusoidal sweeps of 5.5 s duration, was used. It was located in 8 different positions, half of them with the pit in the low position and the other half with the pit at the stage level. Measurement microphones were placed at 21 different positions around the hall. Broadband impulse responses were recorded on all emitter-receiver pairs and parameters defined by ISO-3382:1997 were measured.

During the measurements prior to the works, carried out in November and December 2006, and during those carried out after its completion in March 2010, the textile curtain was used to decouple the main hall from the stagehouse. Throughout the intermediate measurements, the fire curtain made of iron was used for the same purpose.

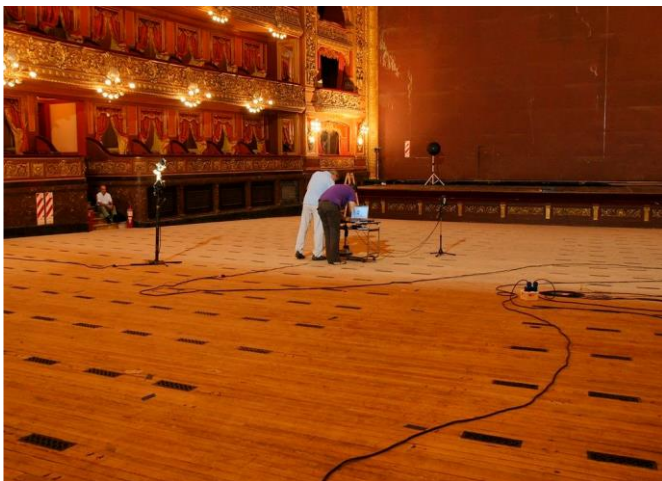
Figure 2 – Measurements in the hall after the removal of the stalls carpets

Intermediate measurements were made, during the staggered disassembly of the hall, in the following sequence:

- After the removal of the seats from the stalls
- After the removal of the stall's carpets
- After the removal of the upper-level seats
- After the removal of the chairs and stools from the boxes
- After the removal of the curtains from the boxes
- After the removal of the carpets from the boxes
- After the removal of the curtains covering the exits
- After the removal of the carpets from the Paradiso level

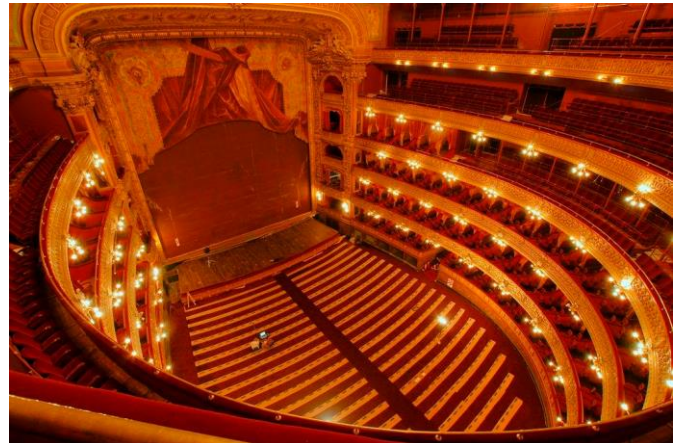
Figure 3 – The hall before putting the seats on the main floor during its reassembly

During the staggered reassembly of the hall, a reverse sequence was followed. Thus, the last measurement in the disassembling and the first measurement in the assembling were carried out with the hall completely devoid of textiles. In this way, the results of the equivalent stages -the ones with the original materials and the ones with the replacement materials- were able to be compared. The objective was to detect any deviation and correct it immediately if necessary.

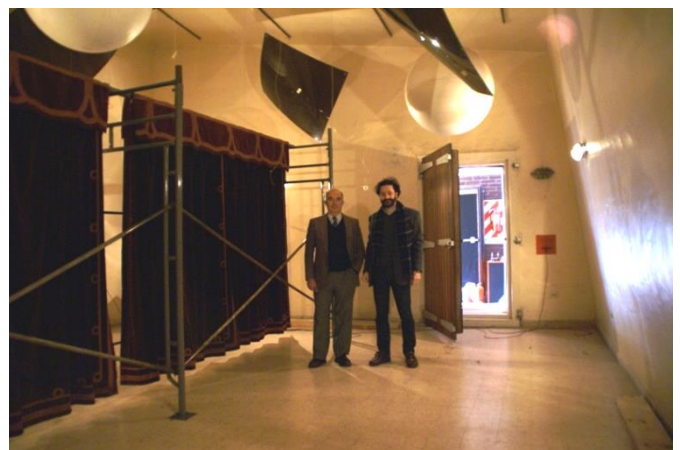
Figure 4 – Laboratory measurement of the hall curtains

Samples of the original elements - curtains, seats, draperies, carpets, etc. - and their replacements were measured at the *Laboratorio de Acústica y Lumineotecnica* (LAL-CIC) of the Province of Buenos Aires.

In almost all cases, the acoustic absorption was measured in a reverberant chamber following the ISO-

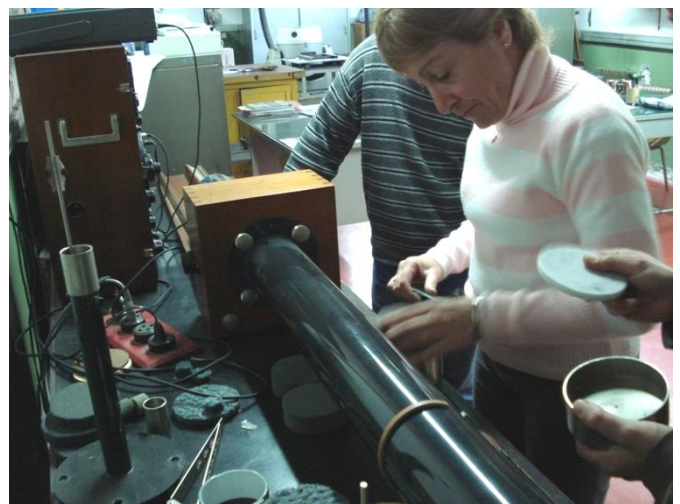
Figure 5 – Kundt tube measurement of the carpets for the Paradiso level

354 standard. In some cases, the standing wave tube method -Kundt tube- was used to carry out preliminary measurements. By way of illustration, the replacement fabric for the upholstery of the seats was finally resolved having discarded the first seven samples that did not meet the required acoustic absorption values.

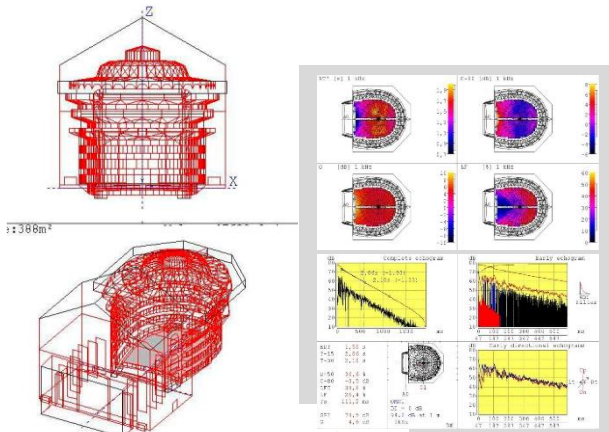
Figure 6 – Views and some predictions of the digital model of the Teatro Colón (*Catt-Acoustic* software)

Simultaneously with the measurements in the hall, a digital acoustic model was developed using the *CATT-Acoustic* software. It was adjusted with the values of the on-site measurements until the errors were similar to those established by the ISO-3382 standard. The model was widely used throughout the process and was very useful for making critical decisions, such as extrapolating the measurements of the absorption of the seats made in the reverberant chamber to the particular acoustics of the theatre.

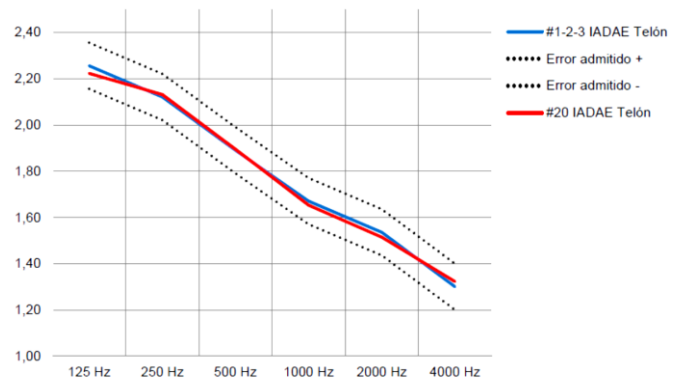
TC - Comparación mediciones T30

Figure 7 – Comparison of the initial (blue curve) and the final (red curve) T30 measurements in the empty hall. Dotted lines represent the error allowed [6]

The comparison between the results of the measurements carried out before and after the restoration work showed that there were no deviations above the margin of error allowed by the standards. For example, Figure 7 shows the global T30 values, with the two curves practically superimposed. The rest of the global ISO-3382 parameters showed a similar agreement.
